AFWAL-TM-79-10

**TEST REPORT ON INFRARED
WARNING RECEIVER (IRWR) FLIGHT
VIBRATION MEASUREMENTS**

APRIL 1980

This test report presents data which define the vibration environments experienced by two infrared warning receiver (IRWR) units mounted on the HH-53 helicopter and the C-130E transport aircraft.

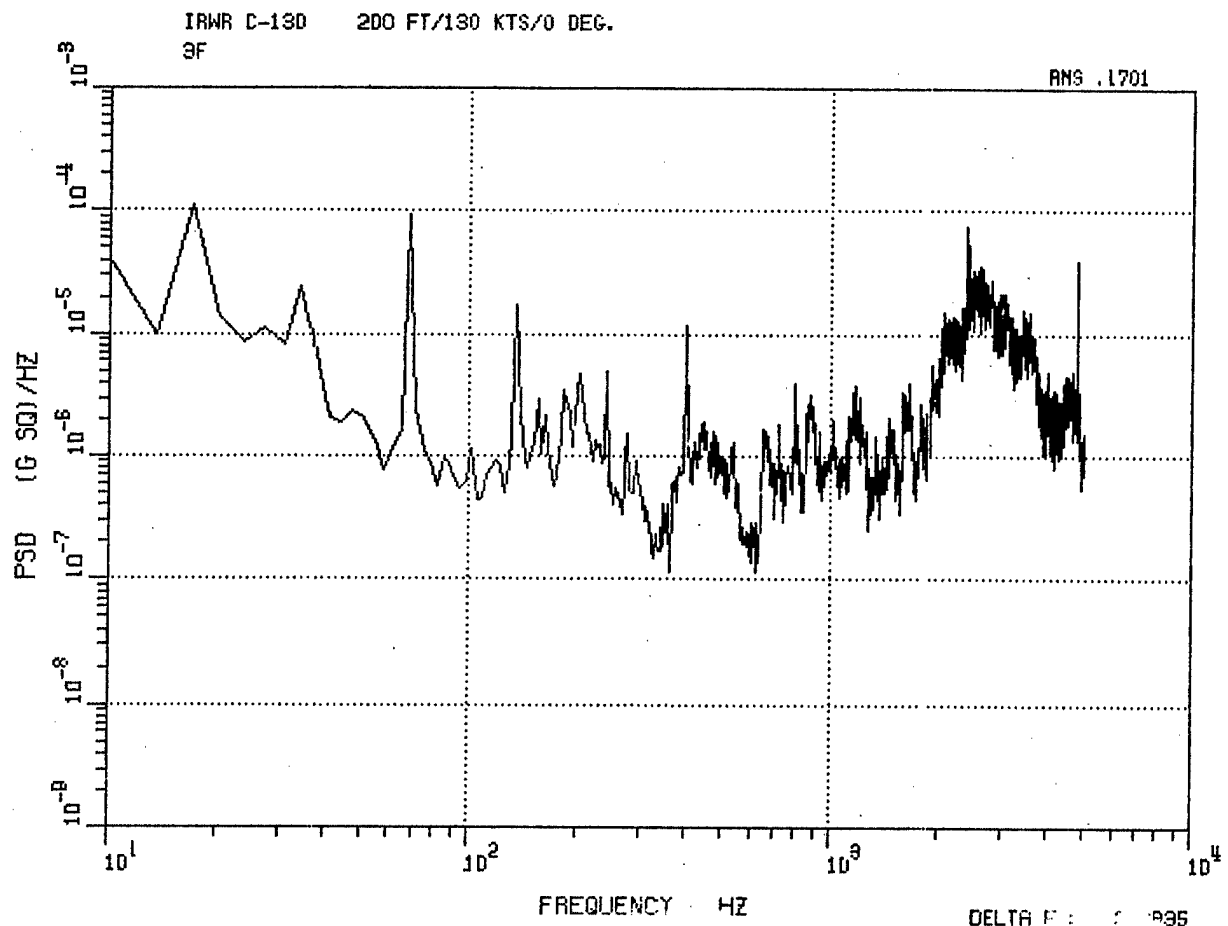
Figure 16. C-130 Fwd Vertical Accelerometer 3F, 200 Ft, 130 Kt, 0 Deg, and 1000 Ft, 130 Kt, 0 Deg.

The vertical acceleration is much lower than the lateral, as shown for Sensor 3F in Figures 16-19. The longitudinal vibration, shown for Sensor 6F in Figures 20-23, is lower still, and is dominated at the higher frequencies by several discrete blade-passage frequencies and overtones. The forward microphone, MF, plotted in Figures 24-27, shows fairly low overall sound-pressure levels. The 400-Hz peak in the microphone data is probably instrument noise. The higher speed flight conditions add about 10 dB to the noise levels at the forward AAR-43 location.

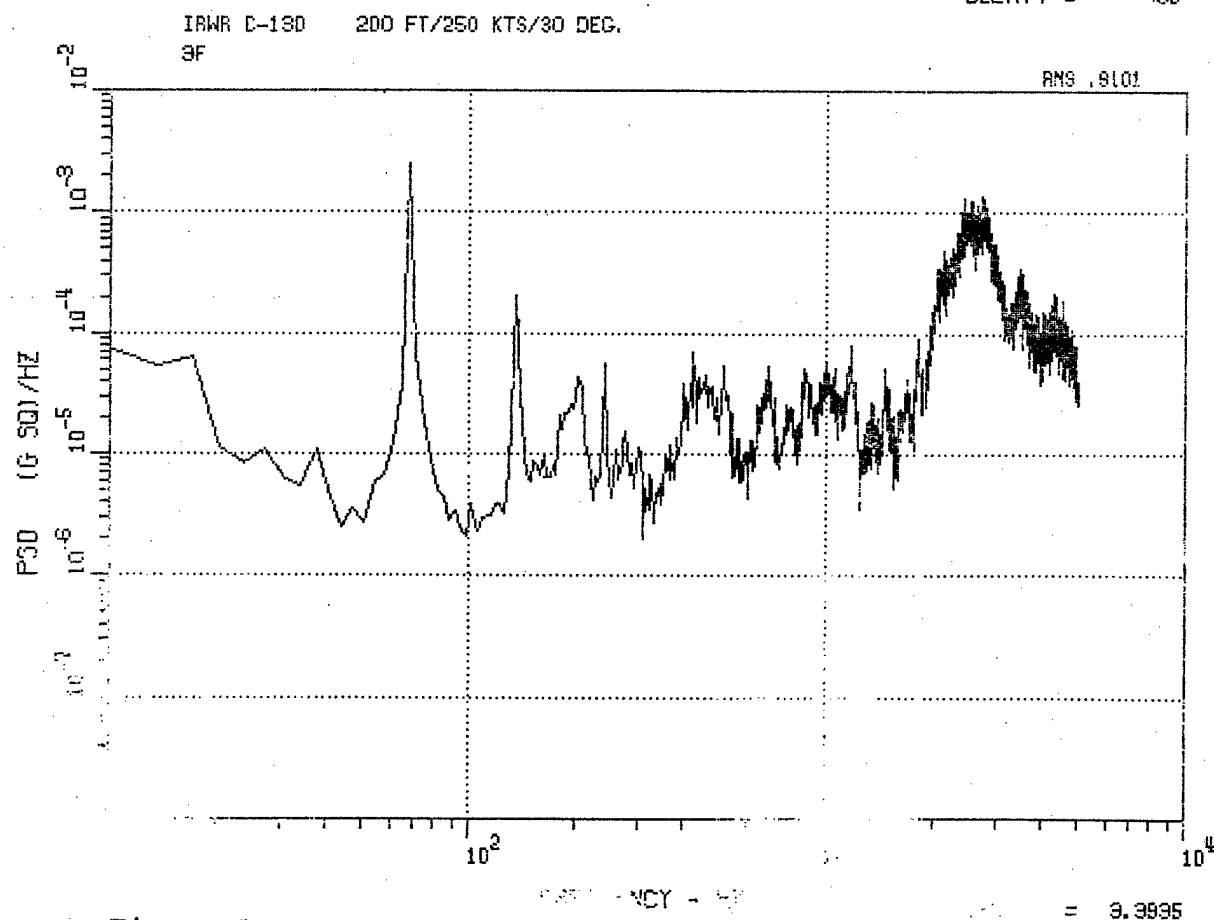
Figure 17. C-130 Fwd Vertical Accelerometer 3F, 5000 Ft, 130 Kt, 0 Deg, and 200 Ft, 250 Kt, 30 Deg.

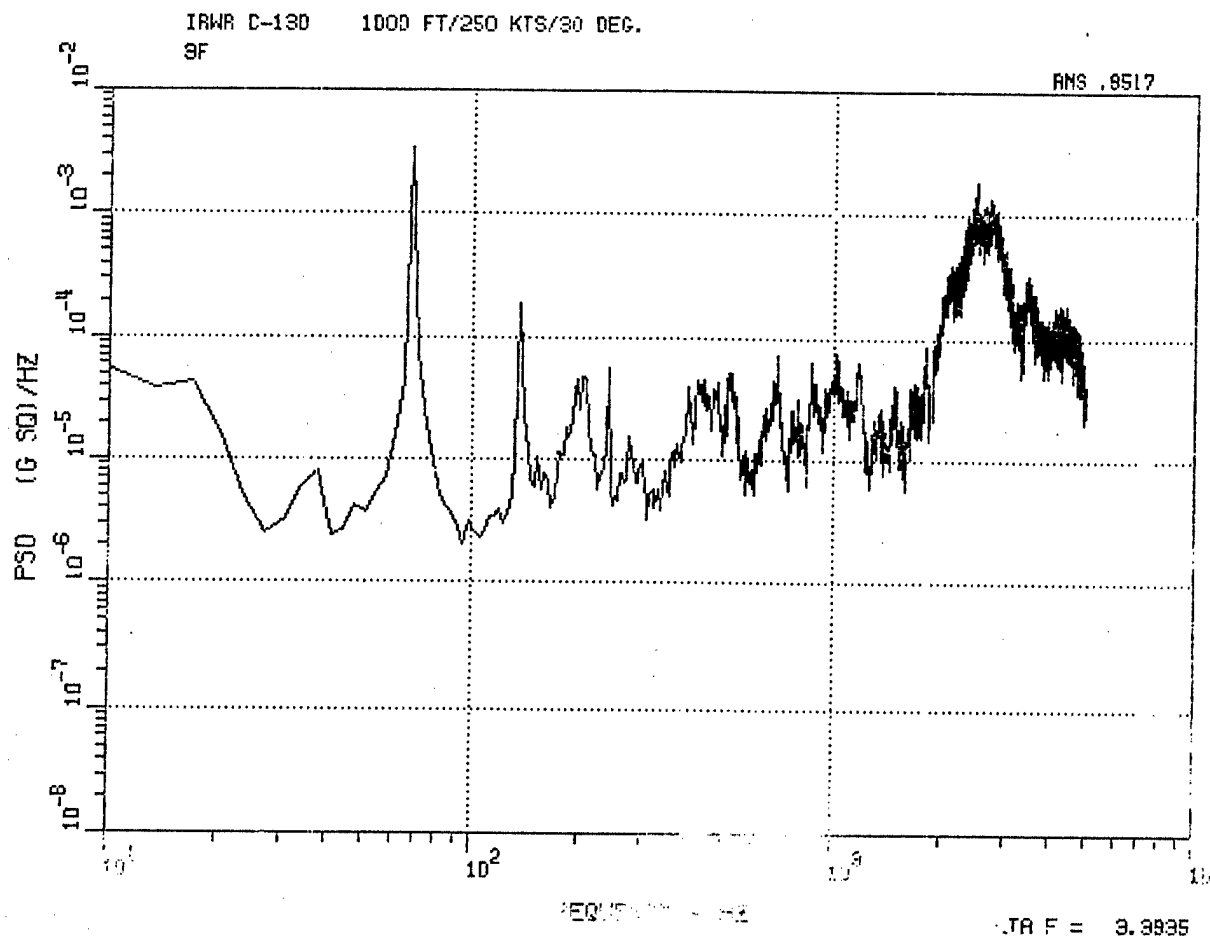
Figure 18. C-130 Fwd Vertical Accelerometer 3F, 1000 Ft, 250 Kt, 30 Deg, and 5000 Ft, 250 Kt, 30 Deg.

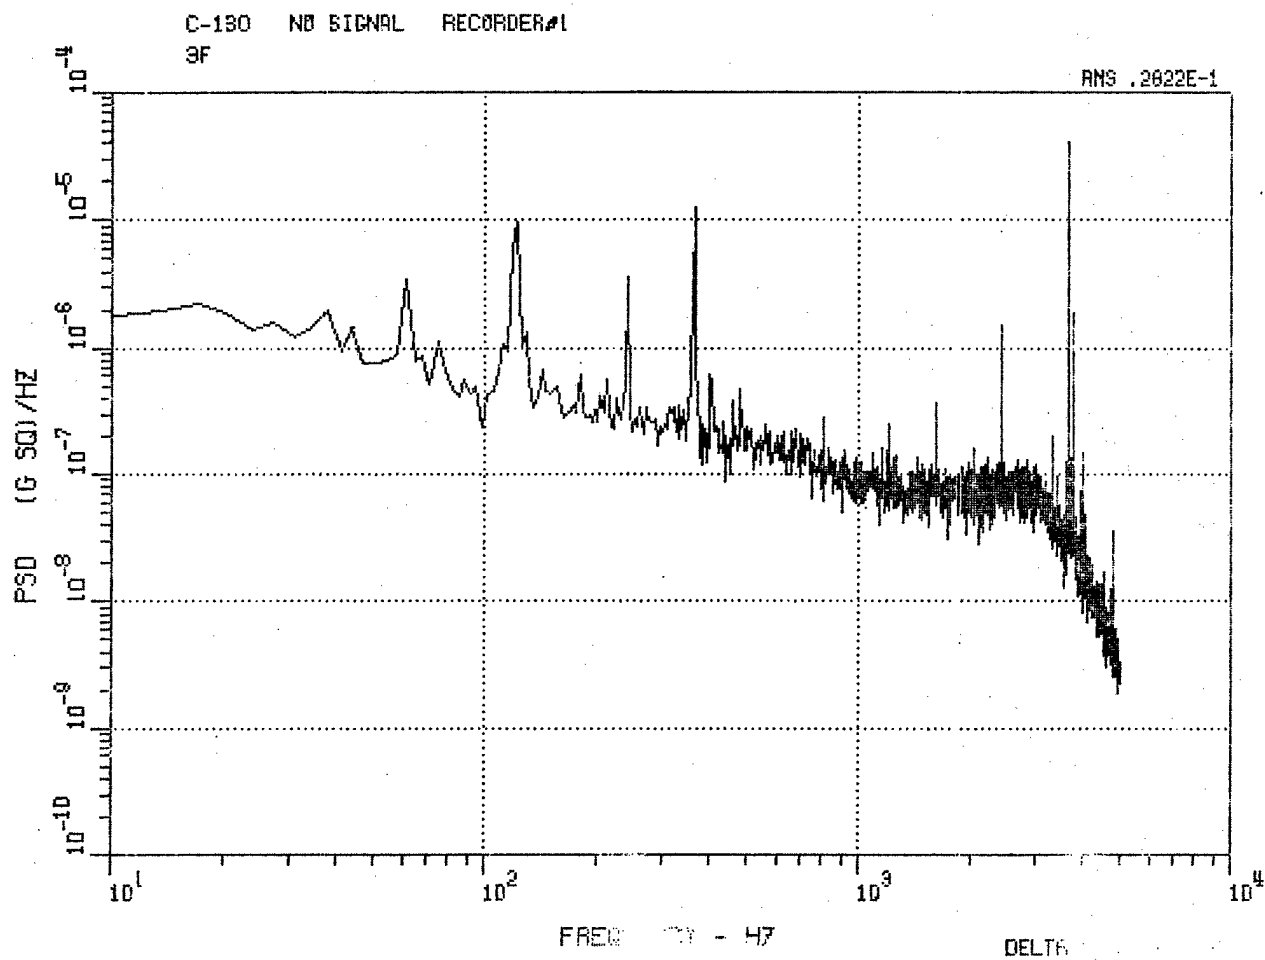
Figure 19. C-130 Fwd Vertical Accelerometer 3F,
No-Signal Record.

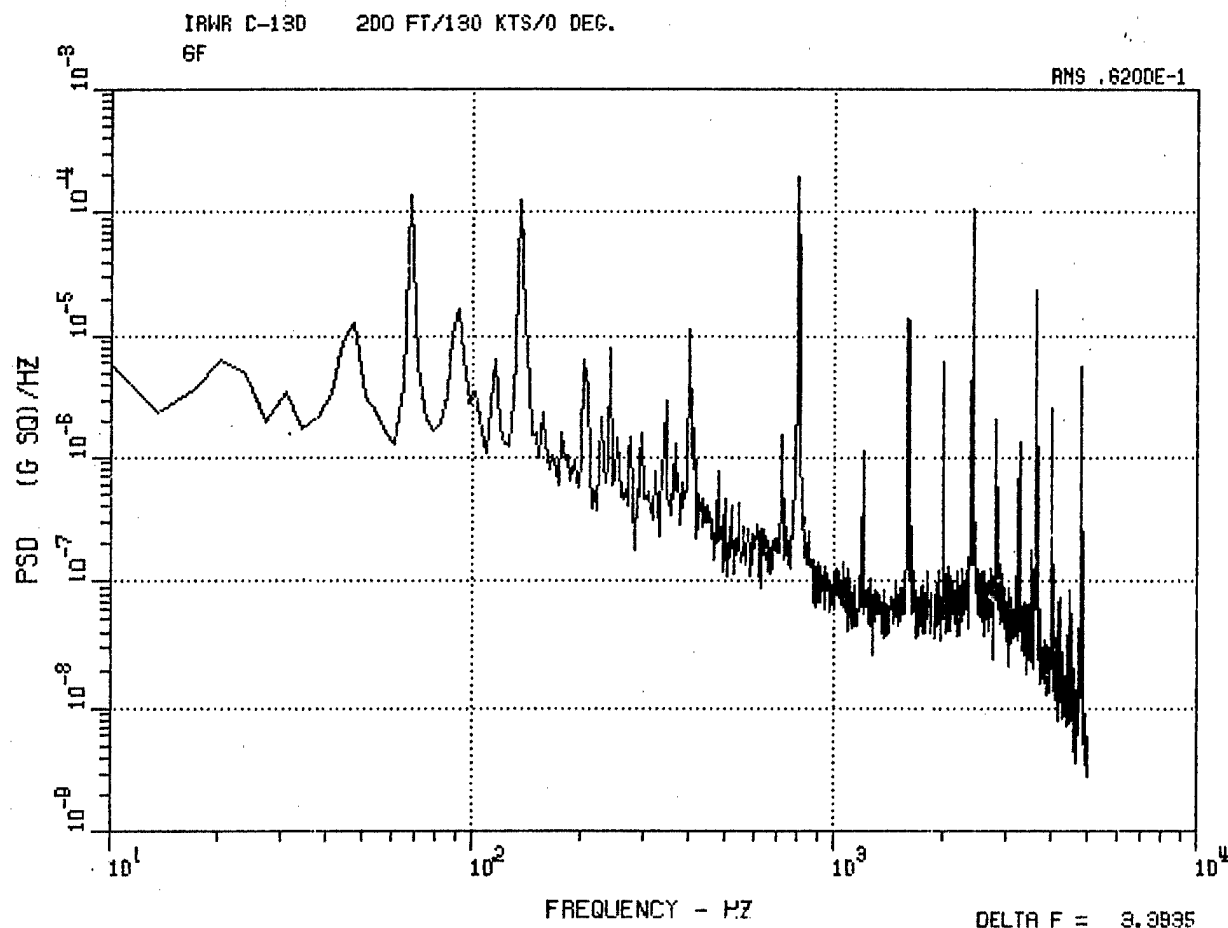
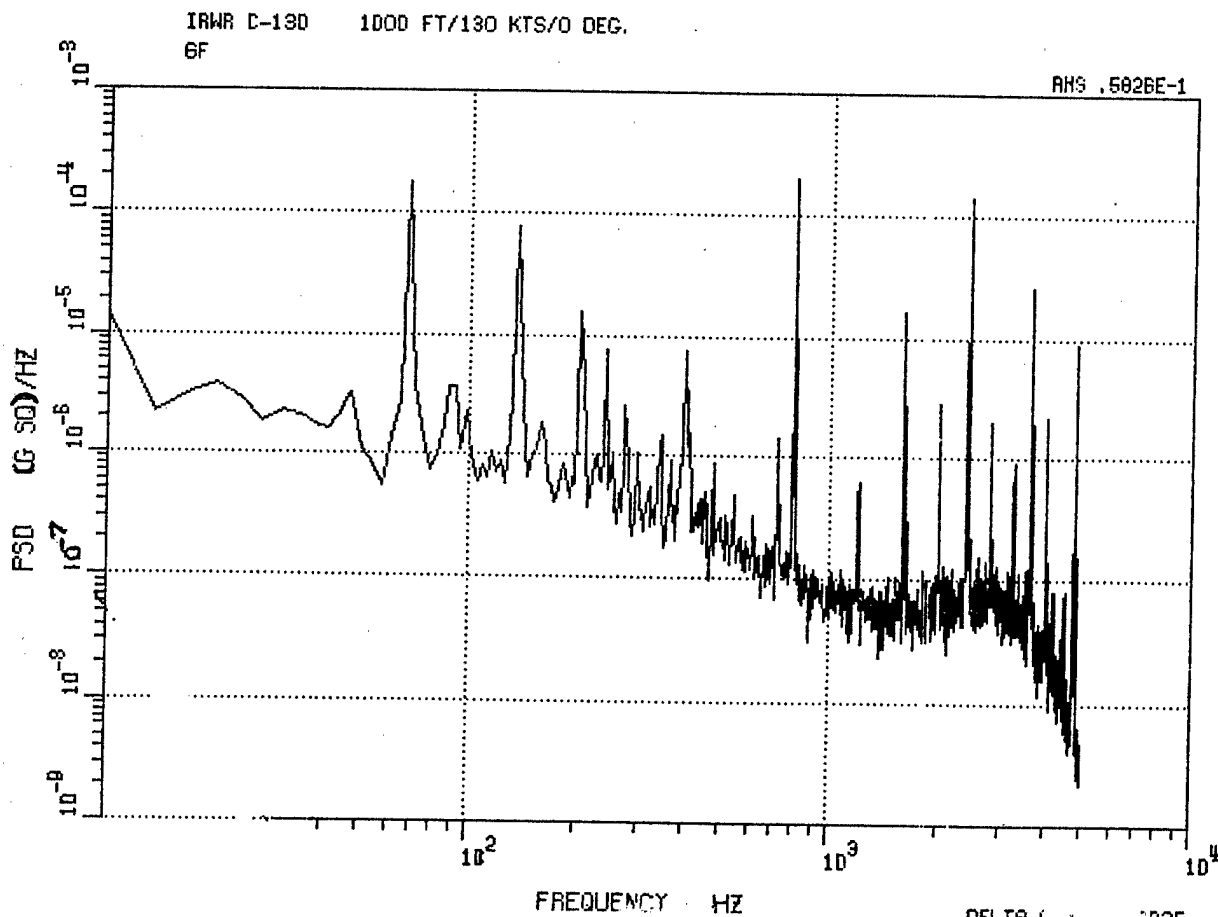
Figure 20. C-130 Fwd Longitudinal Accelerometer 6F, 200 Ft, 130 Kt, 0 Deg, and 1000 Ft, 130 Kt, 0 Deg.

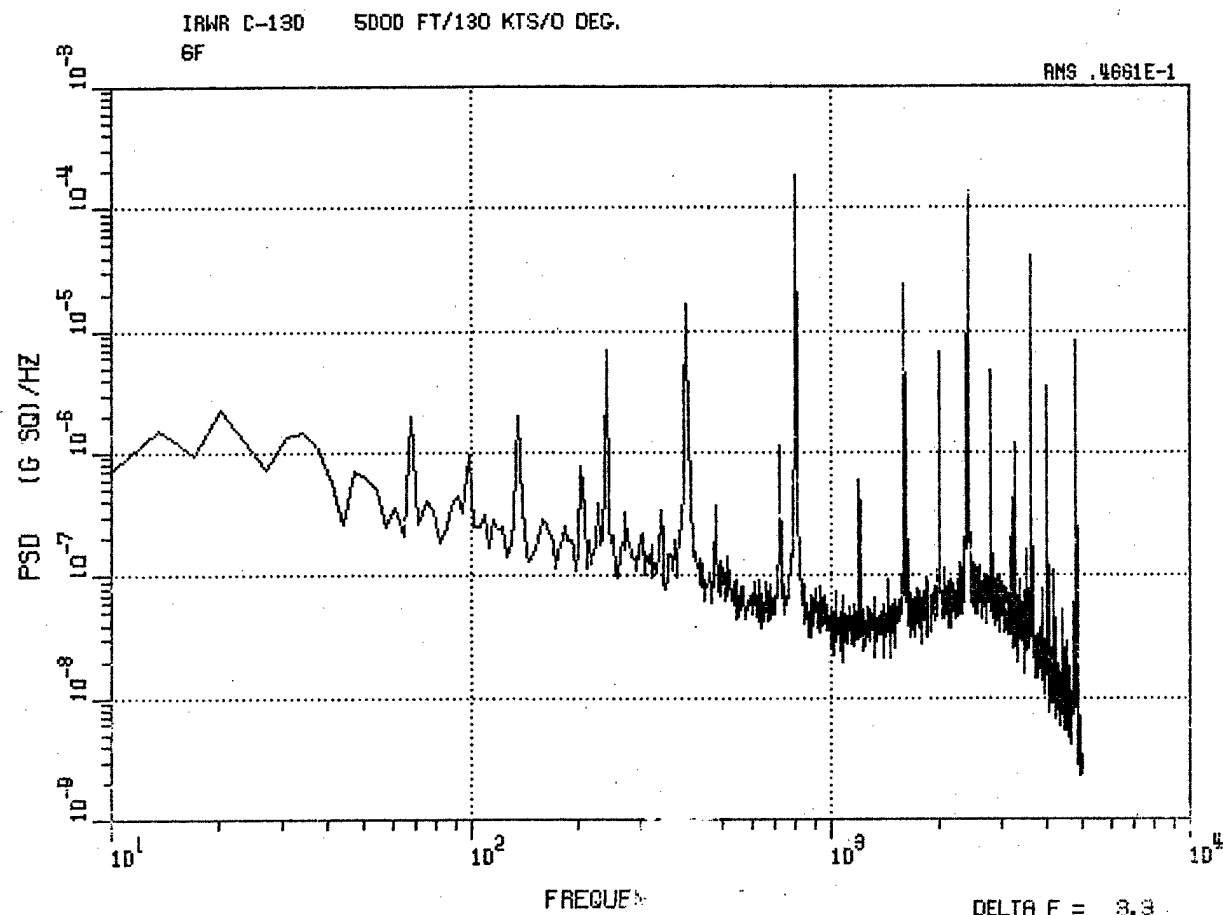
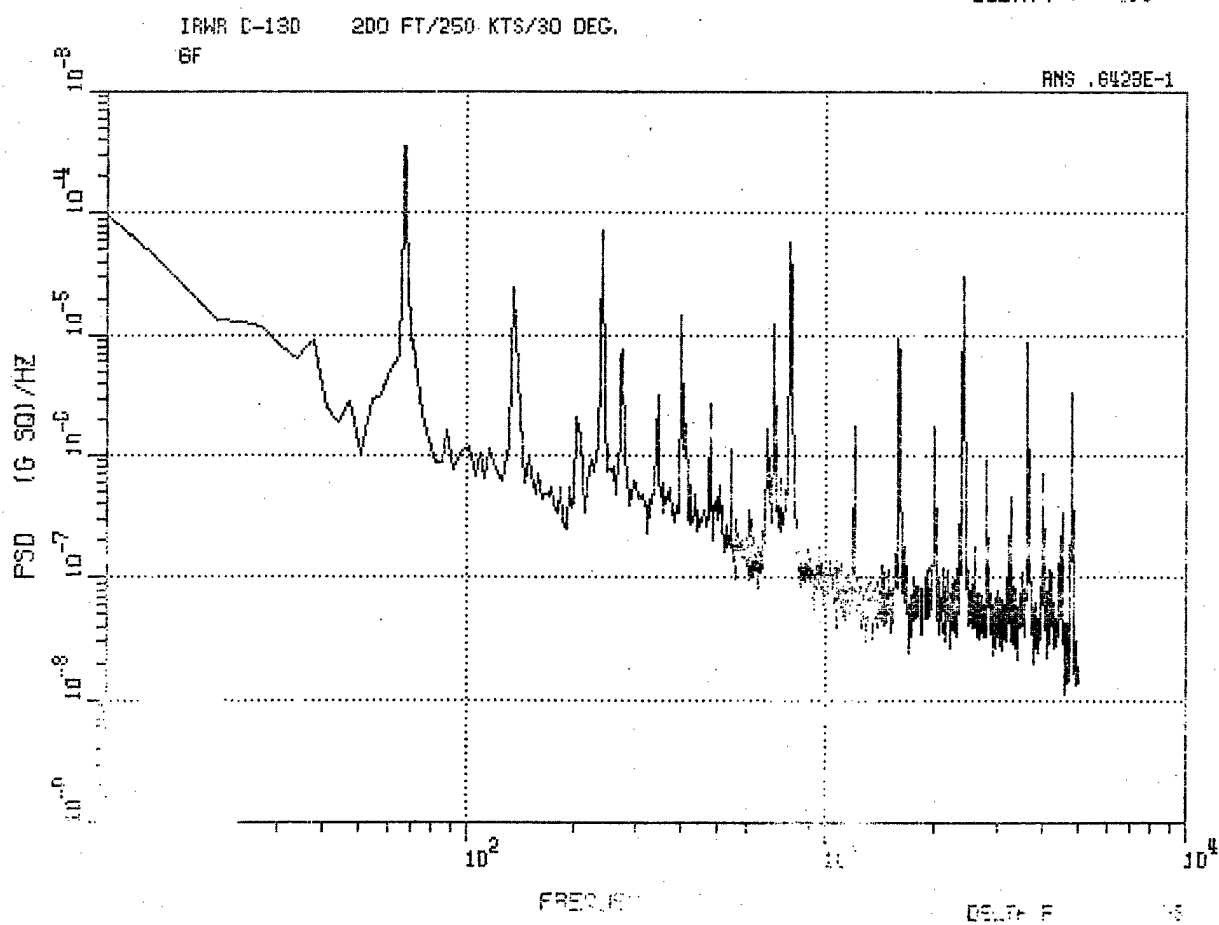
Figure 21. C-130 Fwd Longitudinal Accelerometer 6F, 5000 Ft, 130 Kt, 0 Deg, and 200 Ft, 250 Kt, 30 Deg.

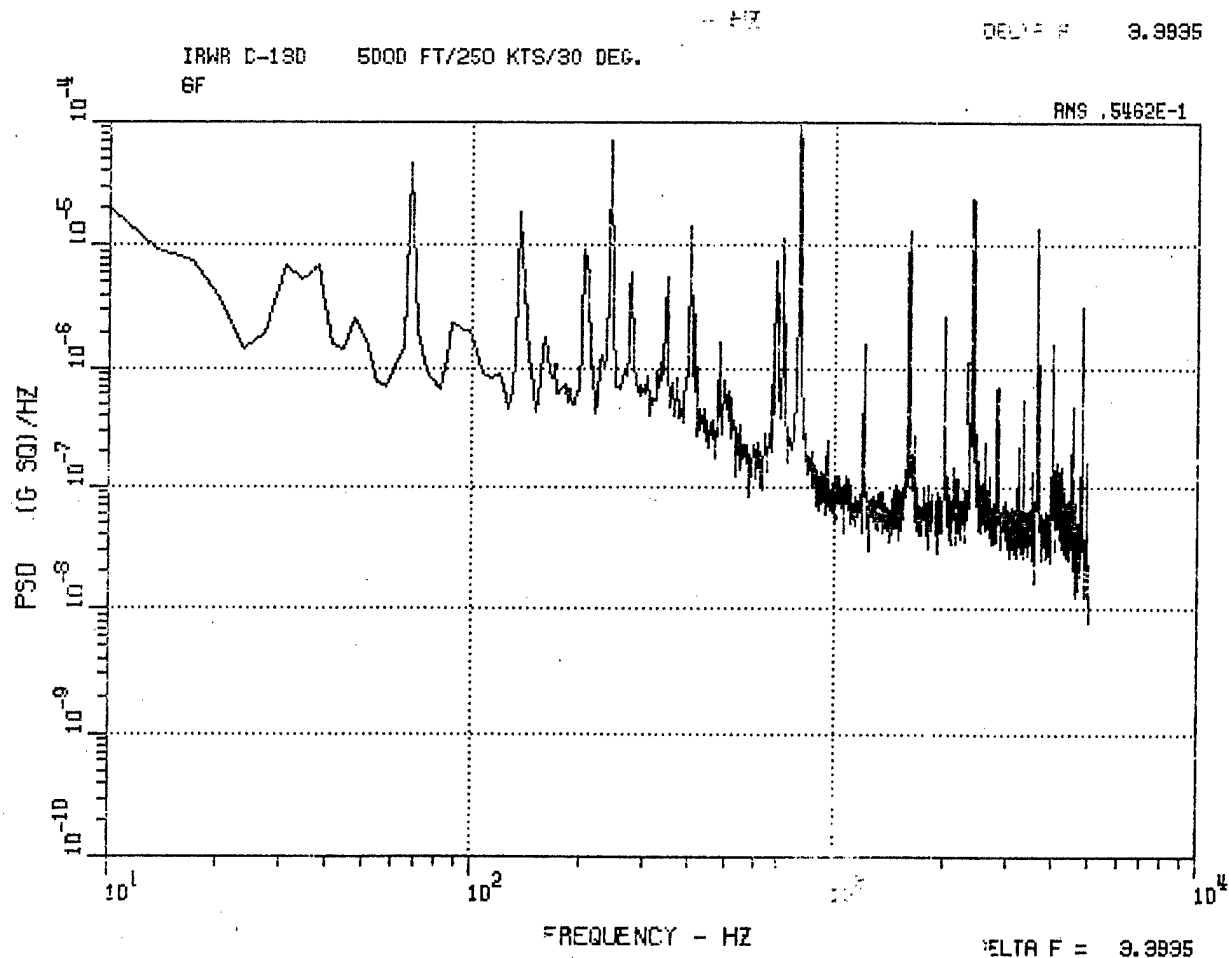
Figure 22. C-130 Fwd Longitudinal Accelerometer 6F, 1000 Ft, 250 Kt, 30 Deg, and 5000 Ft, 250 Kt, 30 Deg.

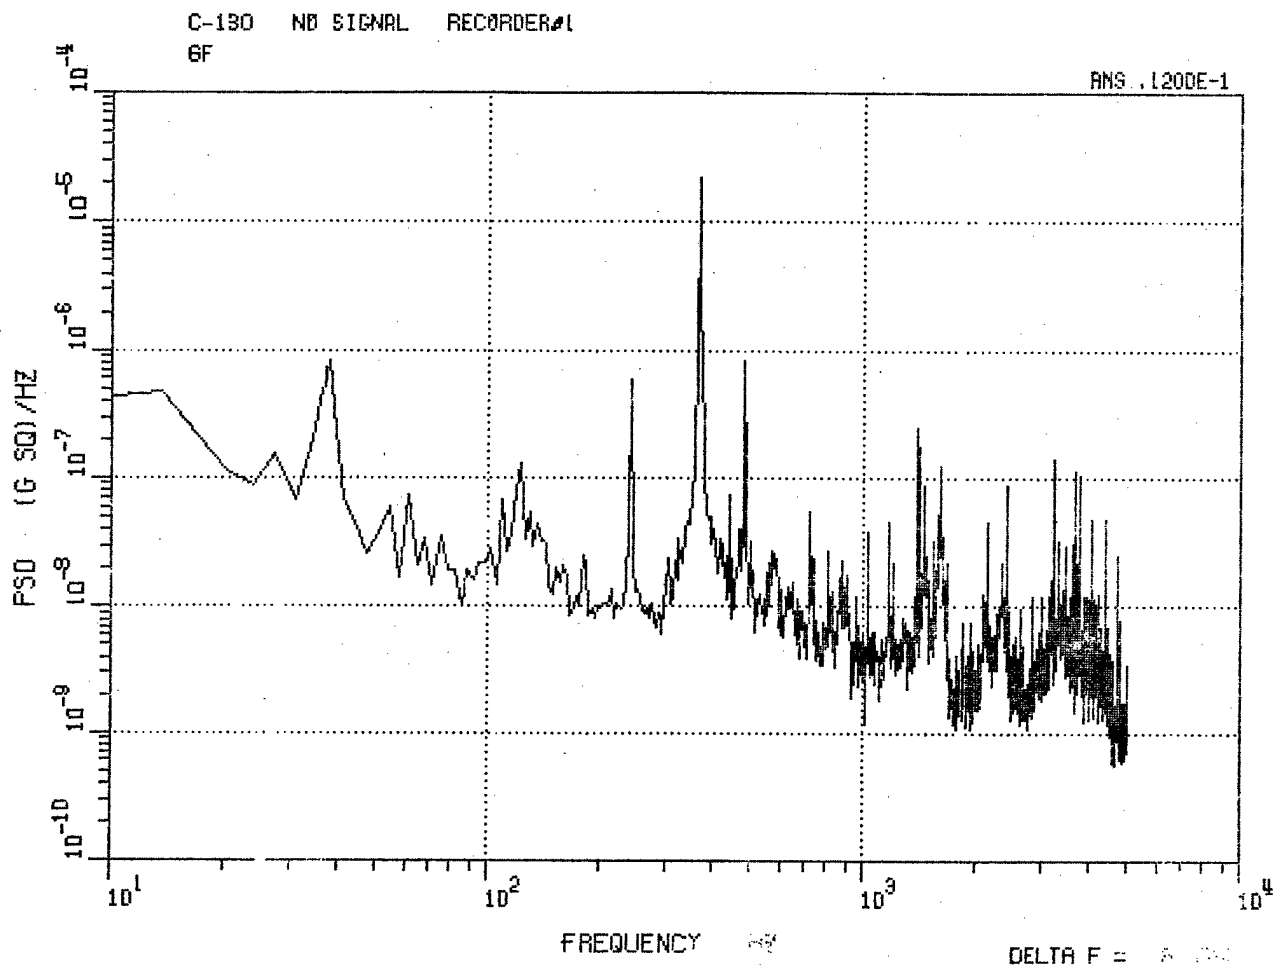
Figure 23. C-130 Fwd Longitudinal Accelerometer 6F,
No-Signal Record.

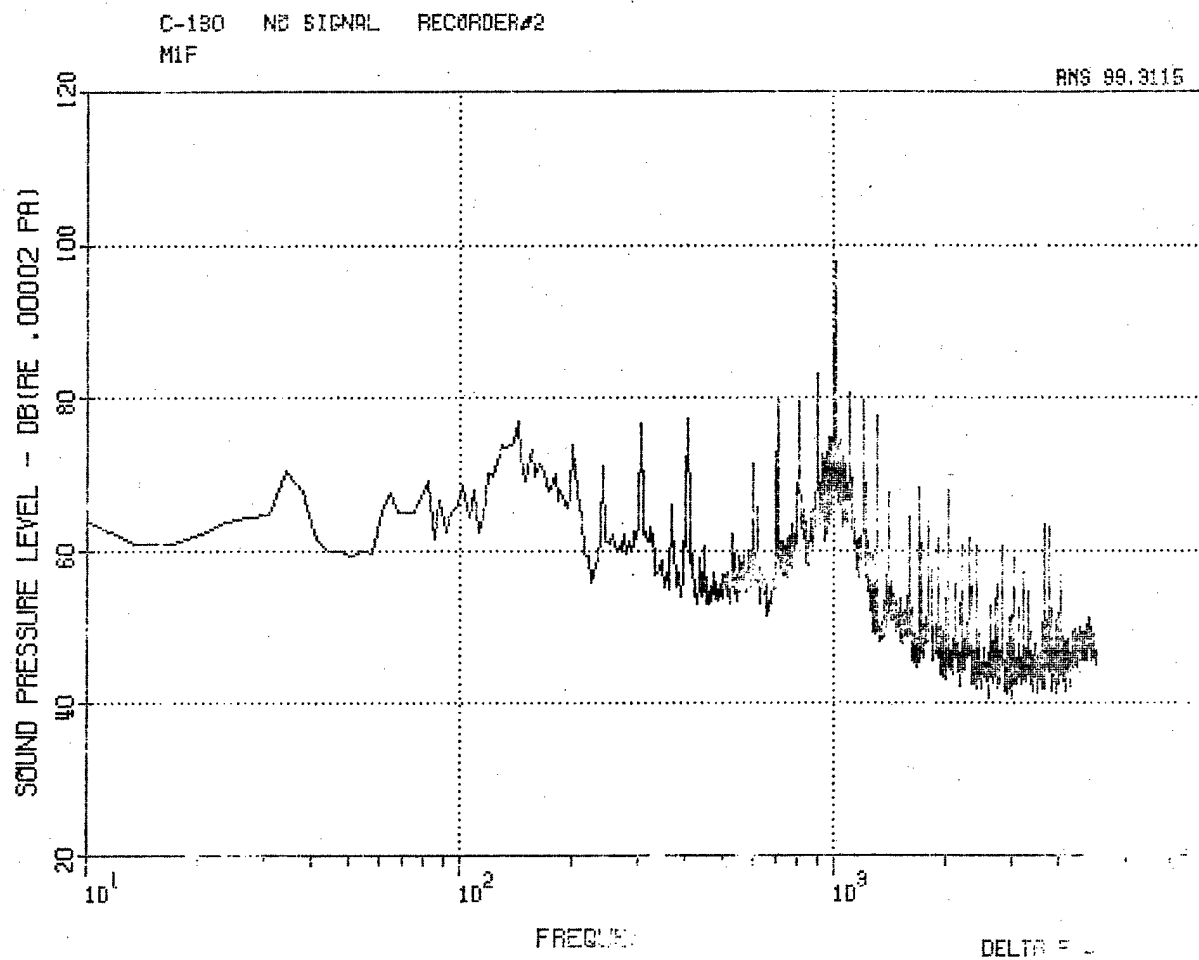
Figure 27. C-130 Fwd Microphone MF, No-Signal Record.

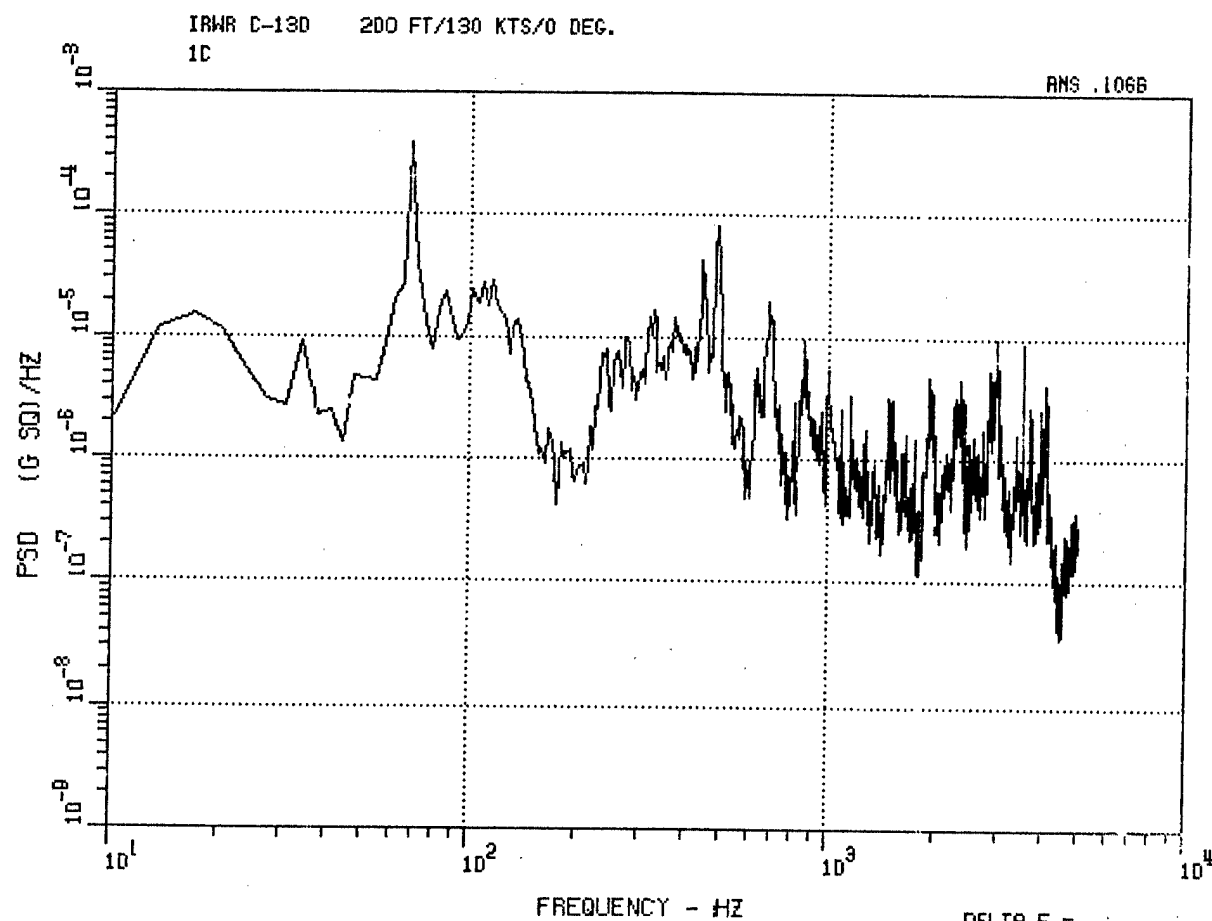
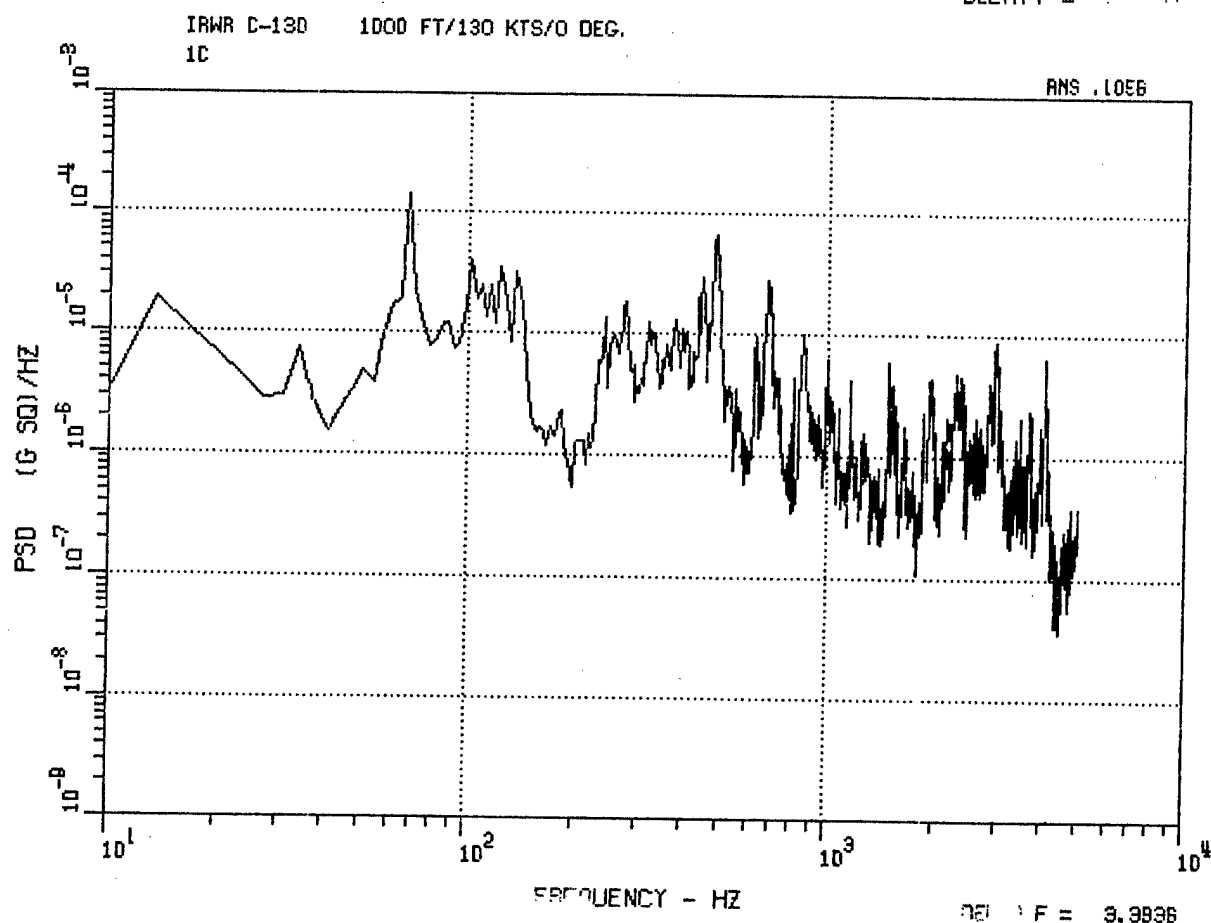
Figure 28. C-130 Center Vertical Accelerometer 1C, 200 Ft, 130 Kt, 0 Deg, and 1000 Ft, 130 Kt, 0 Deg.

The AAR-44 environments on the C-130 are shown in Figures 28-43. The vertical acceleration PSDs for Sensor 1C are shown in Figures 28-41, the lateral PSDs (Sensor 3C) in Figures 32-35, and the longitudinal PSDs (Sensor 6C) in Figures 36-39. The spectra are all distinctly lower in overall rms response than the forward AAR-43 location. The acoustic noise levels, shown in Figures 41-43, are about 16 dB higher than the forward location at 130 knots airspeed and are about 11 dB higher at 250 kts. At the higher flight speeds the noise levels are 139-140 dB, which may cause some difficulty for sensitive electronics.

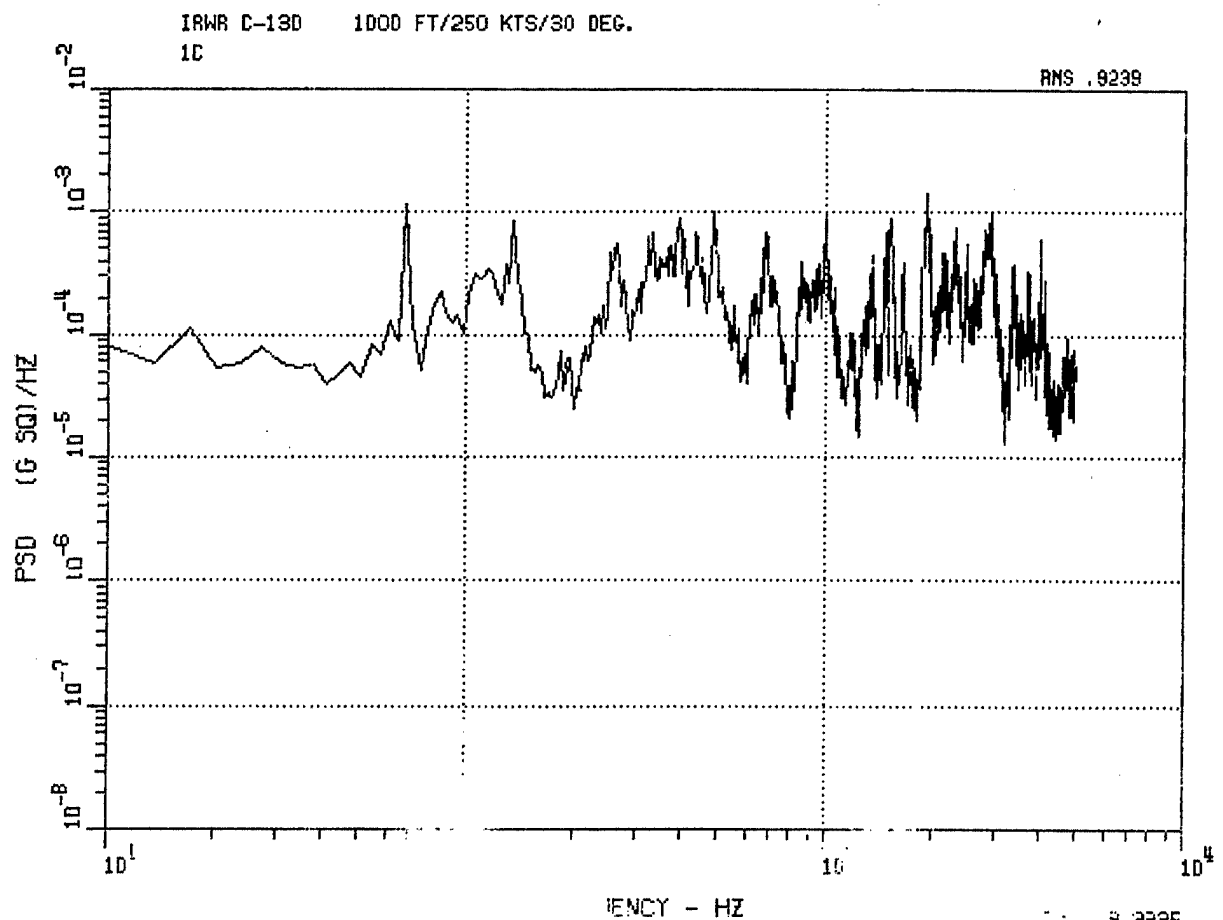
Figure 30. C-130 Center Vertical Accelerometer 1C, 1000 Ft, 250 Kt, 30 Deg, and 5000 Ft, 250 Kt, 30 Deg.

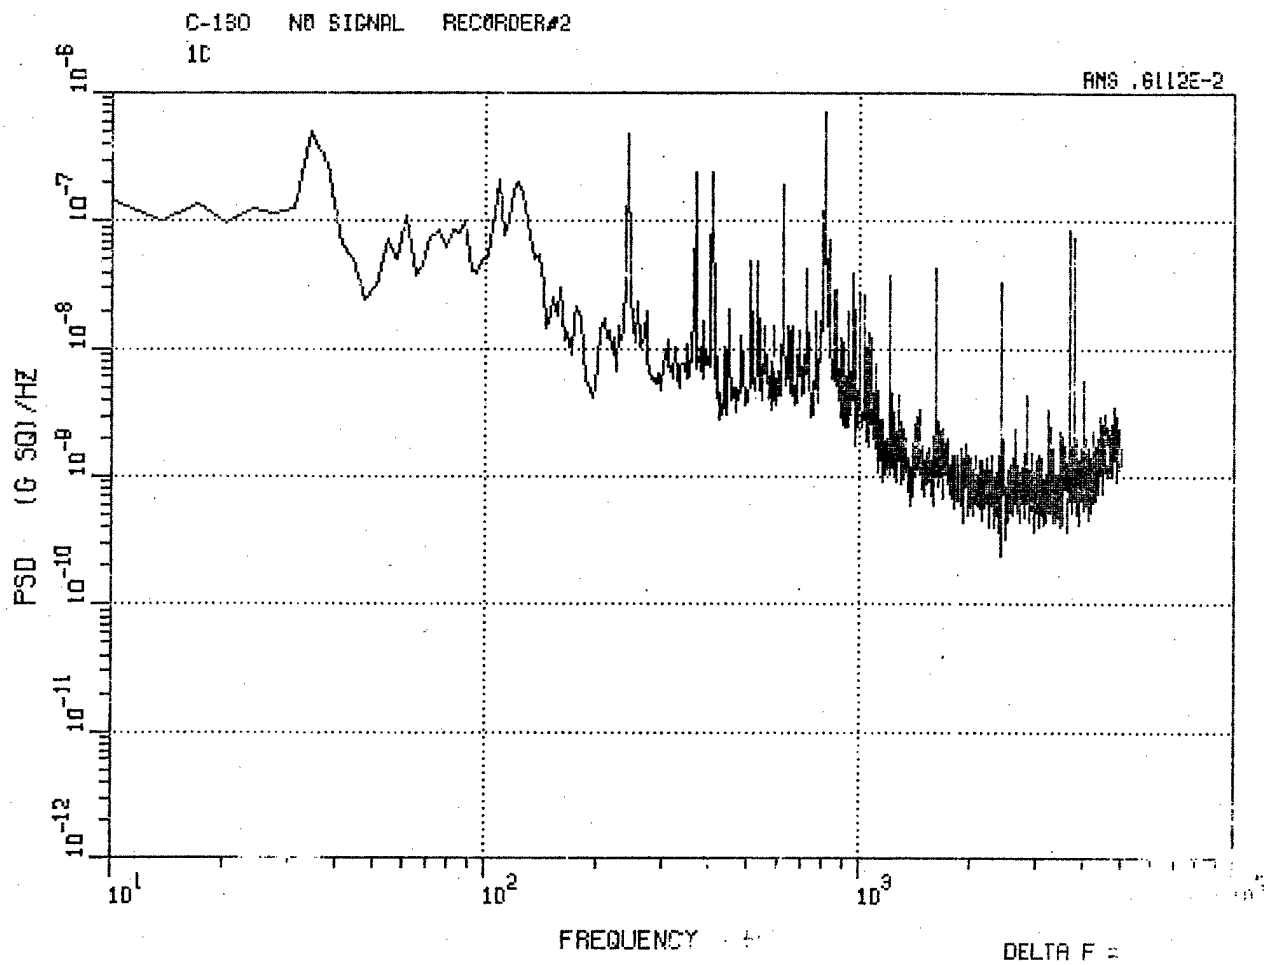
Figure 31. C-130 Center Vertical Accelerometer 1C,
No-Signal Record.

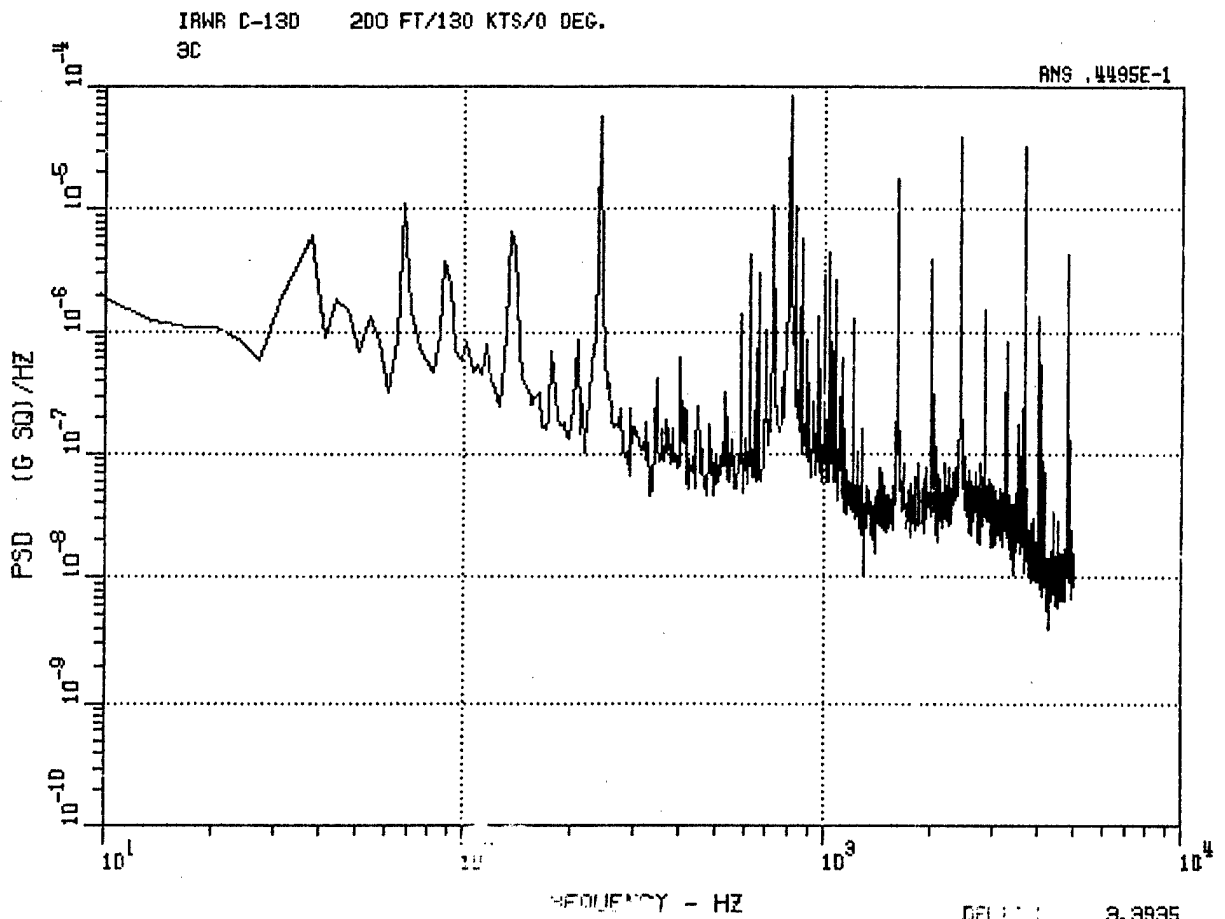
Figure 32. C-130 Center Lateral Accelerometer 3C, 200 Ft, 130 Kt, 0 Deg, and 1000 Ft, 130 Kt, 0 Deg.

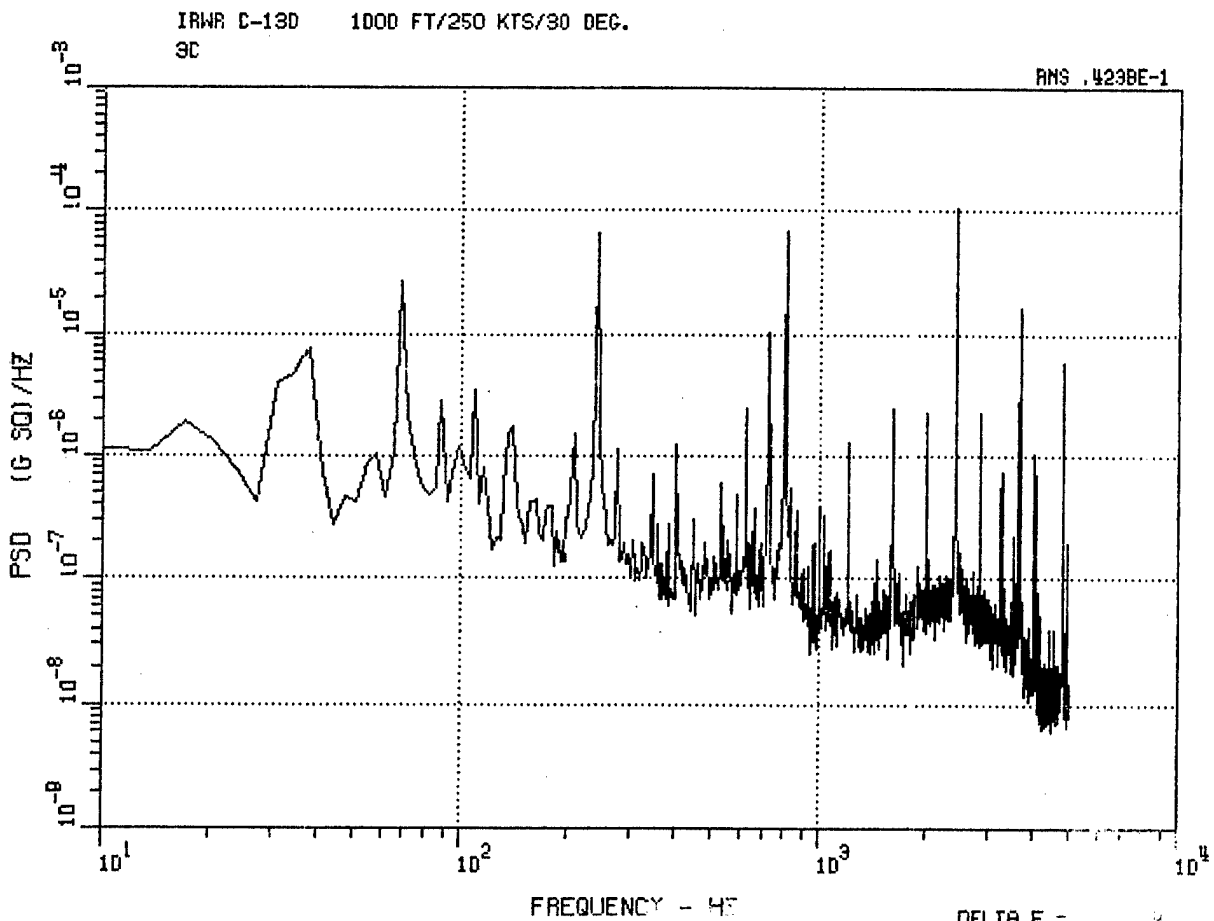
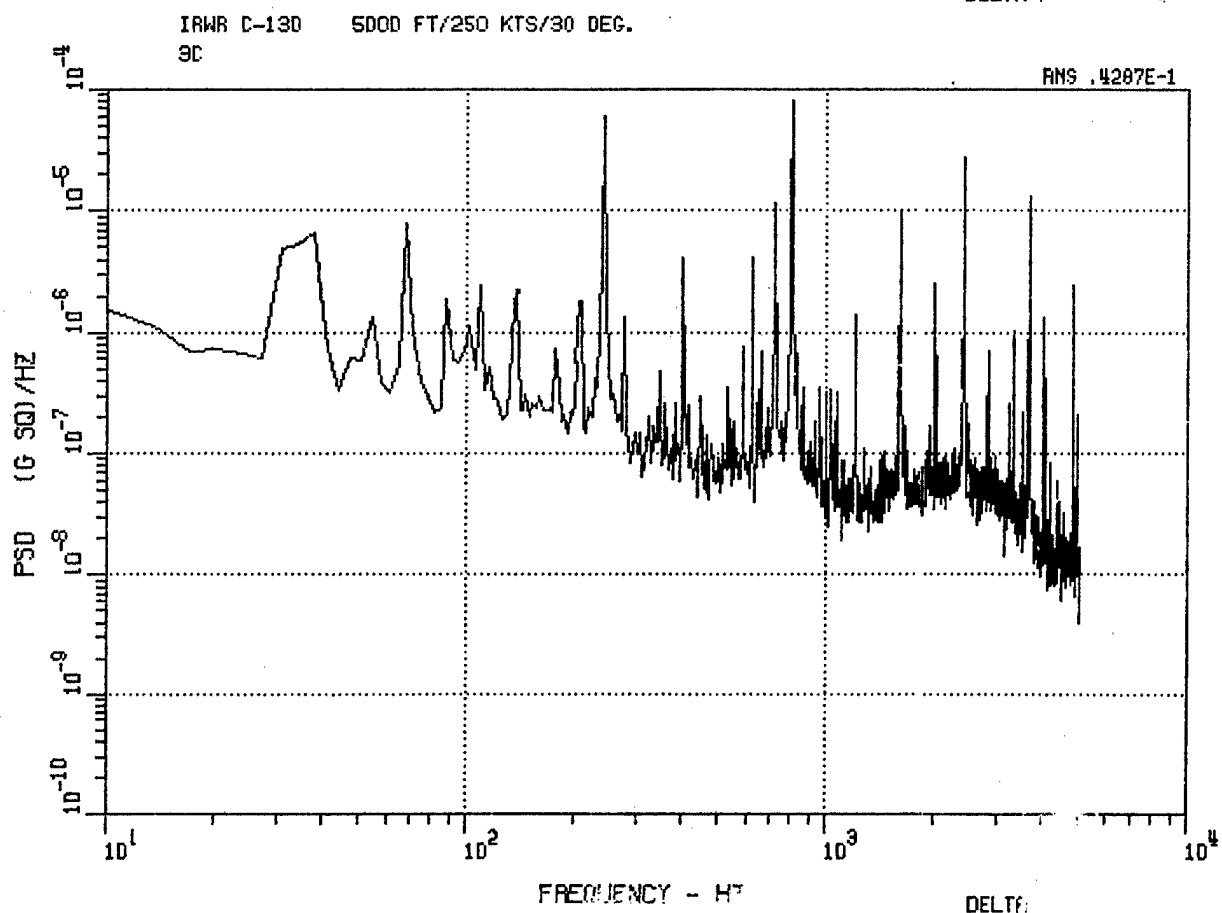
Figure 34. C-130 Center Lateral Accelerometer 3C, 1000 Ft, 250 Kt, 30 Deg, and 5000 Ft, 250 Kt, 30 Deg.

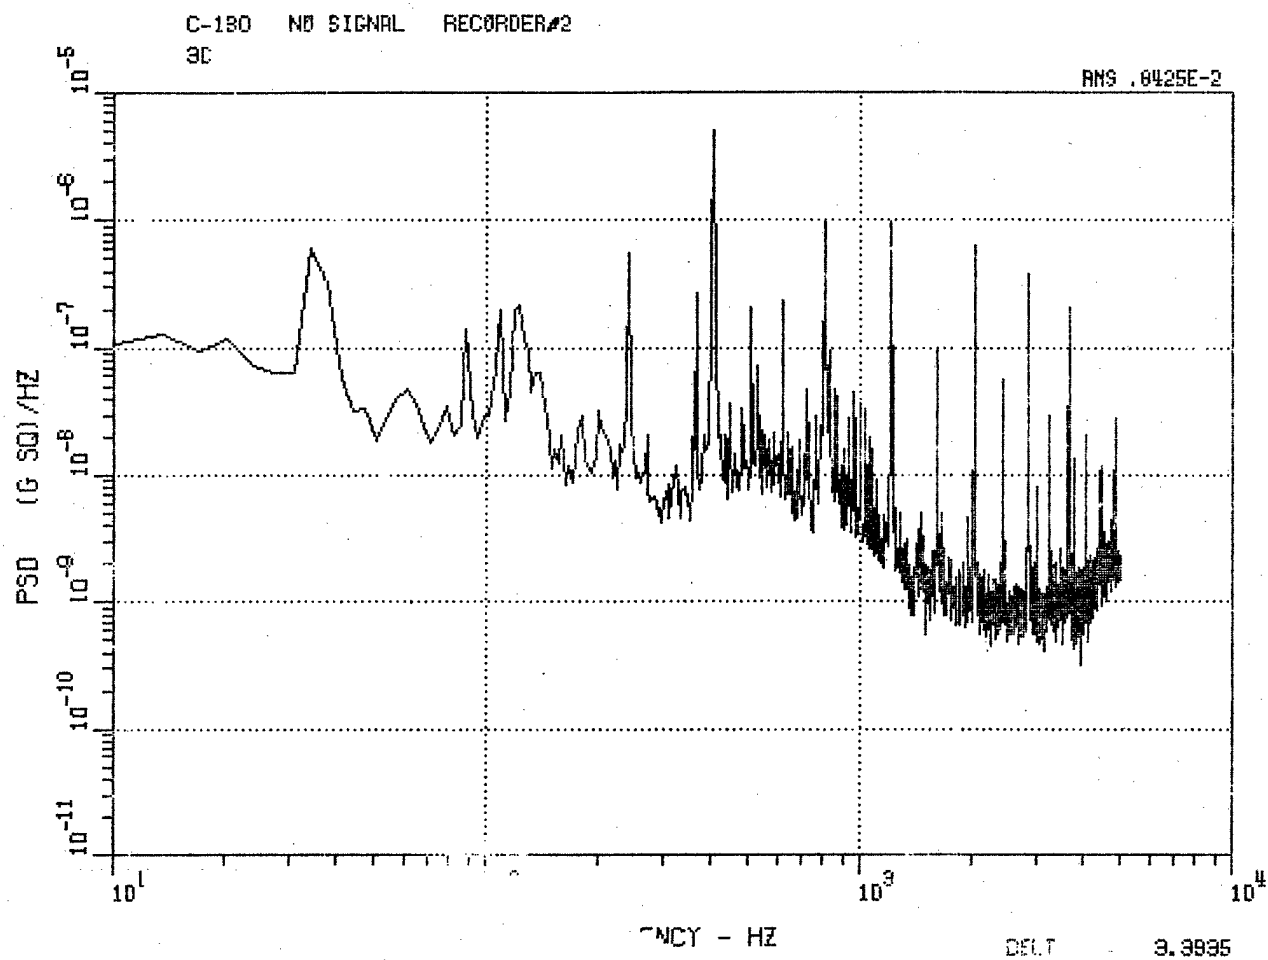
Figure 35. C-130 Center Lateral Accelerometer 3C,
No-Signal Record.
